INDOOR AIR QUALITY ASSESSMENT

Essex Elementary and Middle School 12 Story Street Essex, MA 01929

Prepared by:
Massachusetts Department of Public Health
Center for Environmental Health
Emergency Response/Indoor Air Quality Program
May 2005

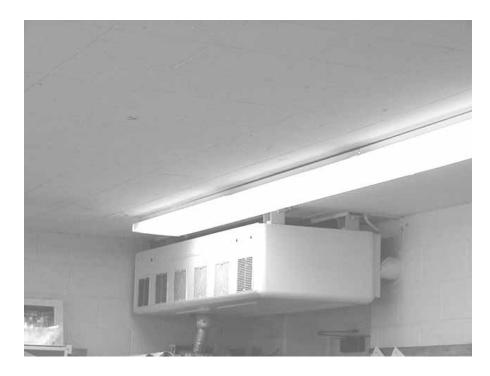
Fresh air in classrooms is supplied by unit ventilator (univent) systems (Pictures 1 and 2). A univent draws air from outdoors through a fresh air intake located on the exterior wall of the building (Picture 3) and returns air through an air intake located at the base of the unit (Figure 1). Fresh and return air are mixed, filtered, heated and provided to classrooms through an air diffuser located in the top of the unit. Univents were not operating throughout the school at the time of the assessment. Obstructions to airflow, such as desks and other items located on or in

Univent

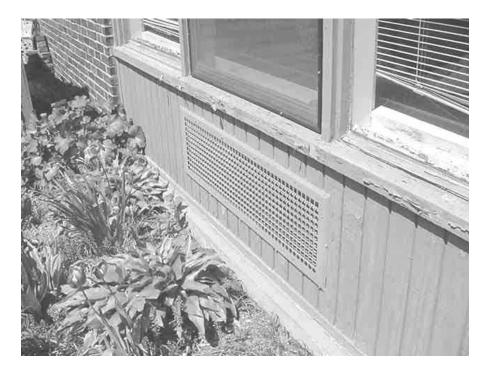
Univent fresh air intake

- 1. Examine each univent for function. Operate univents while classrooms are occupied. Check fresh air intakes for repair and increase the percentage of fresh air intake if necessary.

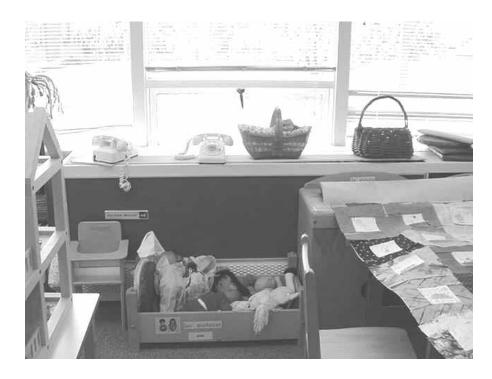
front of univents, were also observed (Picture 4). To function as designed, univents must remain free of obstructions and allowed to operate.

Obstructions to classroom univents

- 4. Remove all obstructions from univents and exhaust vents to facilitate airflow. Close classroom doors to improve air exchange.
- 5. Remove debris and dust accumulated on the ventilation grilles.

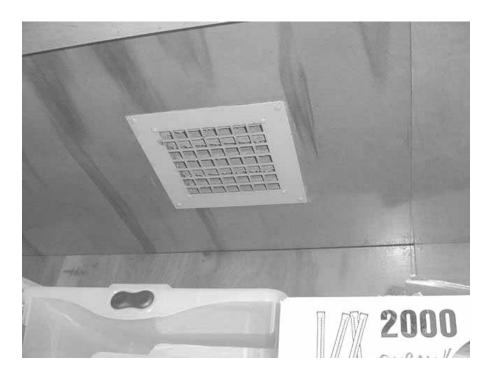
Exhaust ventilation is provided by wall-, closet- or ceiling-mounted exhaust vents (Pictures 5 and 6), which are ducted to motorized rooftop fan units (Picture 7). Exhaust vents were either off, drawing weakly and/or blocked with materials in a number of classrooms surveyed (Picture 8). In addition, some wall vents are located near hallway doors (Picture 6). When hall doors are open, the exhaust is apt to draw hallway air rather than classroom air. As with the univents, exhaust vents must remain free of obstructions and allowed to operate. Classroom doors should also remain closed to facilitate air exchange.

Closet exhaust vent

- 2. Examine exhaust vents for function and make repairs as necessary.
- 3. Operate all ventilation systems that are operable throughout the building (e.g., gym, auditorium, classrooms) continuously during periods of school occupancy independent of thermostat control to maximize air exchange.

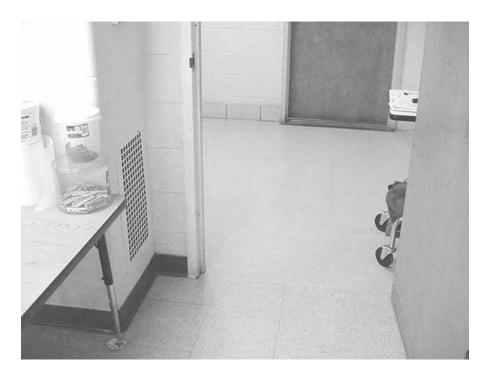
Exhaust vent, note proximity to hallway door

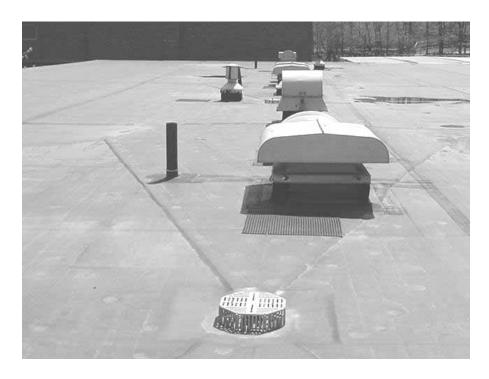
Rooftop exhaust fan

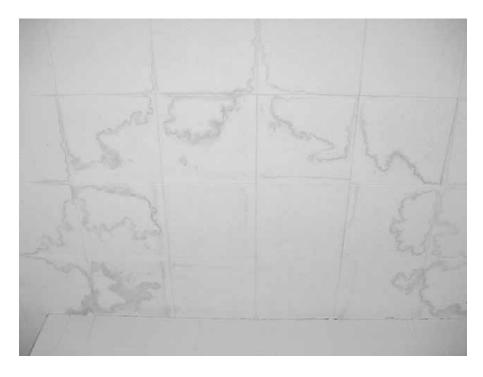
A number of rooms had water-stained ceiling tiles, indicating roof and/or plumbing leaks (Picture 9). Water-damaged ceiling tiles can provide a source of mold growth and should be replaced after a water leak is discovered and repaired. The school has a ceiling tile system where tiles are glued directly to the ceiling. Replacement of these ceiling tiles is difficult, since their removal appears to necessitate the destruction of the tile. Appropriate measures should be taken to minimize the aerosolization of particulates from tile removal/replacement.

Water-damaged ceiling tiles, which are glued directly to ceiling

- 9. Identify and repair sources of water leaks. Replace water-damaged ceiling tiles. These ceiling tiles can be a source of microbial growth. Examine the non-porous surface beneath the removed ceiling tiles and disinfect with an appropriate antimicrobial.

- 10. For removal of tiles directly adhered to the ceiling, such removal would be considered a renovation activity that can release particulates and spores in particular, if the material is moldy. Replacement of ceiling tiles may also involve glues that contain VOCs. In order to minimize occupant exposure, repairs should be done while the building is unoccupied.

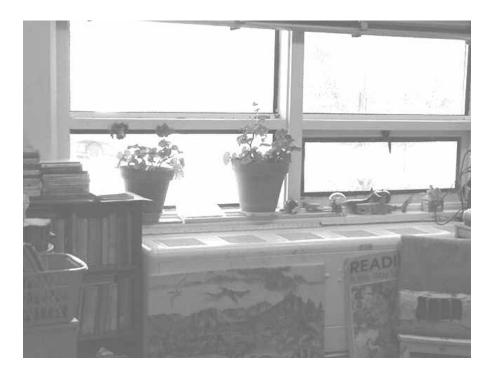
Plants were noted in several classrooms. Some plants were placed near ventilation sources (Picture 10), while others were placed on porous materials (Picture 11). Plants can be a source of pollen and mold, which can be respiratory irritants for some individuals. Plants should also be located away from univents to prevent the aerosolization of dirt, pollen or mold. Plants should also be properly maintained and equipped with drip pans.

Plants near univent

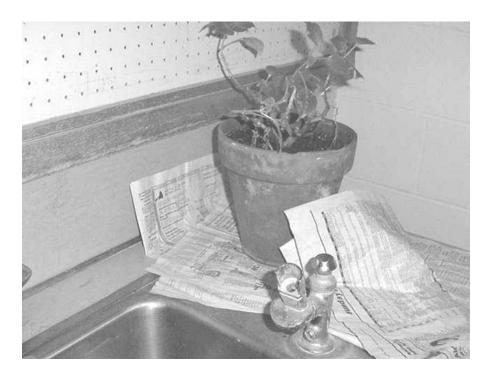
Plant on porous materials

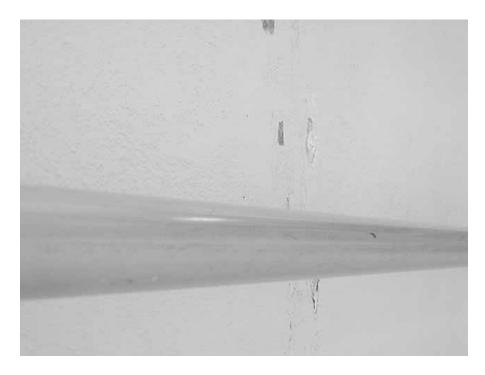
Efflorescence was noted on walls of the ramp way leading to the art area (Picture 12). The ramp way is built below ground and the exterior portion of the wall is in contact with soil (Picture 13). Efflorescence is a characteristic sign of water damage to building materials such as cement or plaster, but it is not mold growth. As moisture penetrates and works its way through exterior walls, water-soluble compounds dissolve, creating a solution. As the solution moves to the surface of the interior wall, water evaporates, leaving behind white, powdery mineral deposits. Efflorescence noted on these walls is likely the result of moisture from the soil in contact with the building.

Efflorescence on ramp way walls

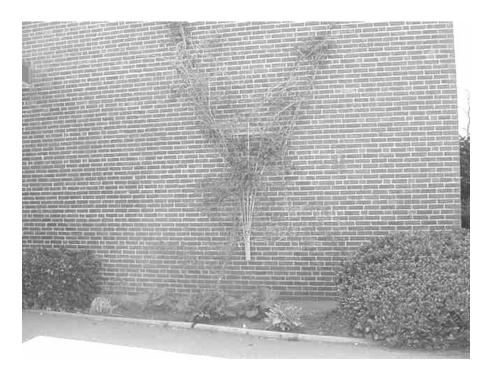
substantial clinging plant growth (Picture 15). Clinging plants can cause damage to brickwork through the insertion of tendrils into brick and mortar. Water can penetrate into the brick along the tendrils, which can subsequently freeze and thaw during the winter. This freezing/thawing action can weaken bricks and mortar, resulting in damage. This type of plant growth on brickwork is not recommended.

Clinging plant growth in exterior wall

- 12. Remove plants growing against building and its foundation to prevent water intrusion through brickwork.
- 13. Ensure water is flowing in the ramp and crawlspace water channels. Examine and remove any debris that may impede water movement.

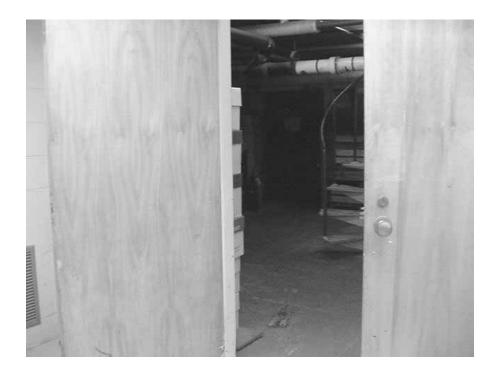
As discussed, a crawlspace is located in the school. The basement level storage area opens to the crawlspace area. The storage and crawlspace areas are accessible either via the technology room or by way of a staircase that leads from the main level to the basement (Picture 16). At the time of the assessment, the door to the storage area was not secured. In addition, the door to the stairway from the main level was open. Open doors, breaches and other openings (e.g., utility holes) allow for crawlspace odors and materials to penetrate occupied areas of the school. Doors should remain closed and breaches should be sealed to prevent movement of materials from the unoccupied storage and crawlspace areas to occupied areas of the school.

Technology room doorway and staircase leading to storage and crawlspace areas

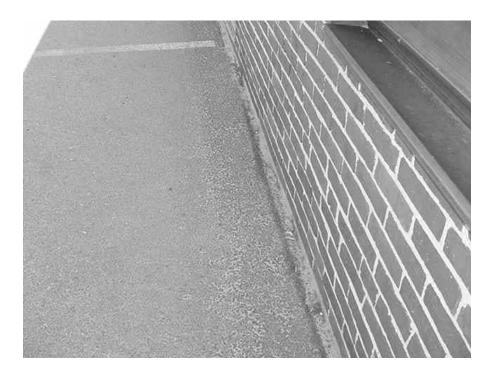
Shrubbery and other plants were also observed to be growing in cracks and crevices in close proximity to the foundation walls (Picture 17). The growth of roots against the exterior walls can bring moisture in contact with wall brick and eventually lead to cracks and/or fissures in the foundation below ground level. Over time, this process can undermine the integrity of the building envelope and provide a means of water entry into the building through capillary action through foundation concrete and masonry (Lstiburek & Brennan, 2001).

Plant growth against foundation

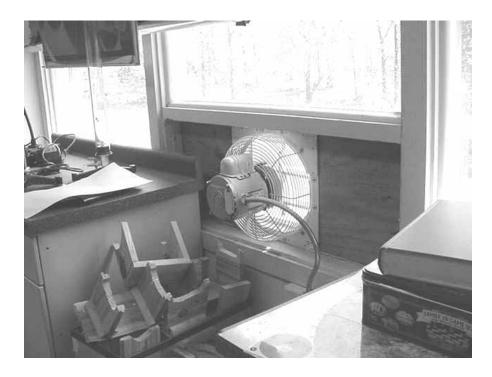
According to occupants in classroom 9, the room experiences a buildup of chemical odors when science laboratory classes are in progress. An auxiliary window exhaust fan was installed to remove odors (Picture 18). Despite operation of the window fan, occupants reported some residual odors when conducting laboratory experiments. Occupants should ensure the fan

Auxiliary window fan in classroom 9

is operating at least 15-20 minutes prior to and following any laboratory work. In addition, ventilation equipment should be operating at all times a classroom is occupied. At the time of the assessment, the classroom univent was off and the classroom wall exhaust function was being hindered as a result of an open door.

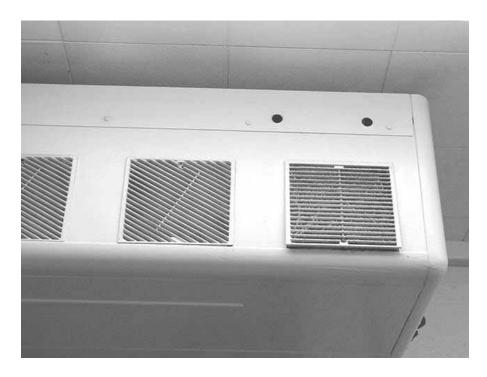
A number of exhaust/return vents, univent supply vents and personal fans were observed to have accumulated dust (Pictures 19 and 20). If exhaust vents are not functioning, backdrafting can occur, which can re-aerosolize accumulated dust particles. Re-activated univents and fans call also aerosolize dust accumulated on vents/fan blades.

Dust on univent supply

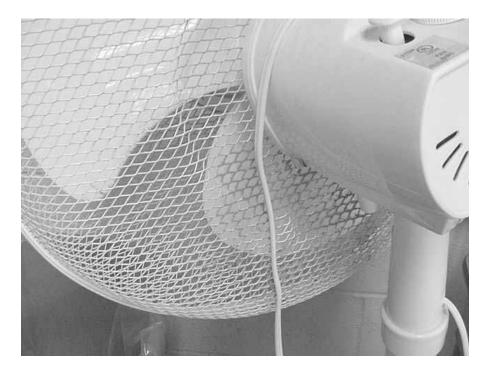
Dust on blades personal fan

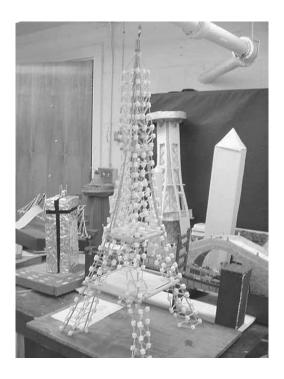
Of note was the use of food as project materials (Picture 21). Exposed food products and reused food containers can attract a variety of pests. The presence of pests inside a building can produce conditions that can degrade indoor air quality. For example, rodent infestation can

Food-based project

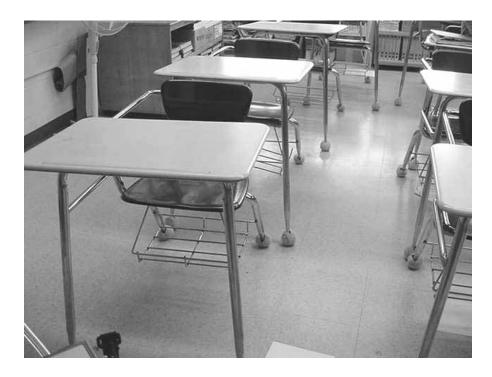
In an effort to reduce noise from sliding chairs, tennis balls had been spliced open and placed on chair legs (Picture 22). Tennis balls are made of a number of materials that are a source of respiratory irritants. Constant wearing of tennis balls can produce fibers and off-gas VOCs. Tennis balls are made with a natural rubber latex bladder, which becomes abraded when used as a chair leg pad. Use of tennis balls in this manner may introduce latex dust into the school environment. Some individuals are highly allergic to latex (e.g., spina bifida patients) (SBAA, 2001). It is recommended that the use of materials containing latex be limited in buildings to reduce the likelihood of symptoms in sensitive individuals (NIOSH, 1997). A question and answer sheet concerning latex allergy is attached as Appendix B (NIOSH, 1998).

Tennis balls on chair legs

- 18. Consider discontinuing the use of tennis balls on furniture and replacing tennis balls with alternative "glides". Refer to Picture 24 for an example.

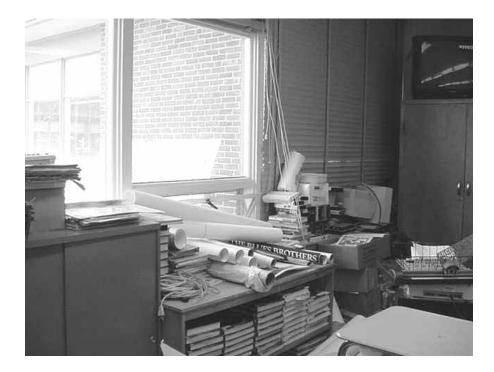
Also was the amount of materials stored inside classrooms (Picture 23). In classrooms throughout the school, items were seen on windowsills, tabletops, counters, bookcases and desks. The amount of items stored in classrooms provides a means for dusts, dirt and other potential respiratory irritants to accumulate and make it difficult for custodial staff to clean.

Amount of materials in classrooms

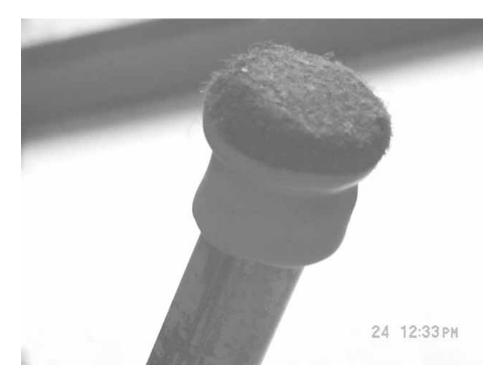
"Glides" for chair legs that can be used as an alternative to tennis balls
